S-340
Cedar Lane Farm
Princess Anne vicinity
private

Maryland Historical Trust State Historic Sites Inventory Form

Survey No. S-340

Cedar Lane Farm description

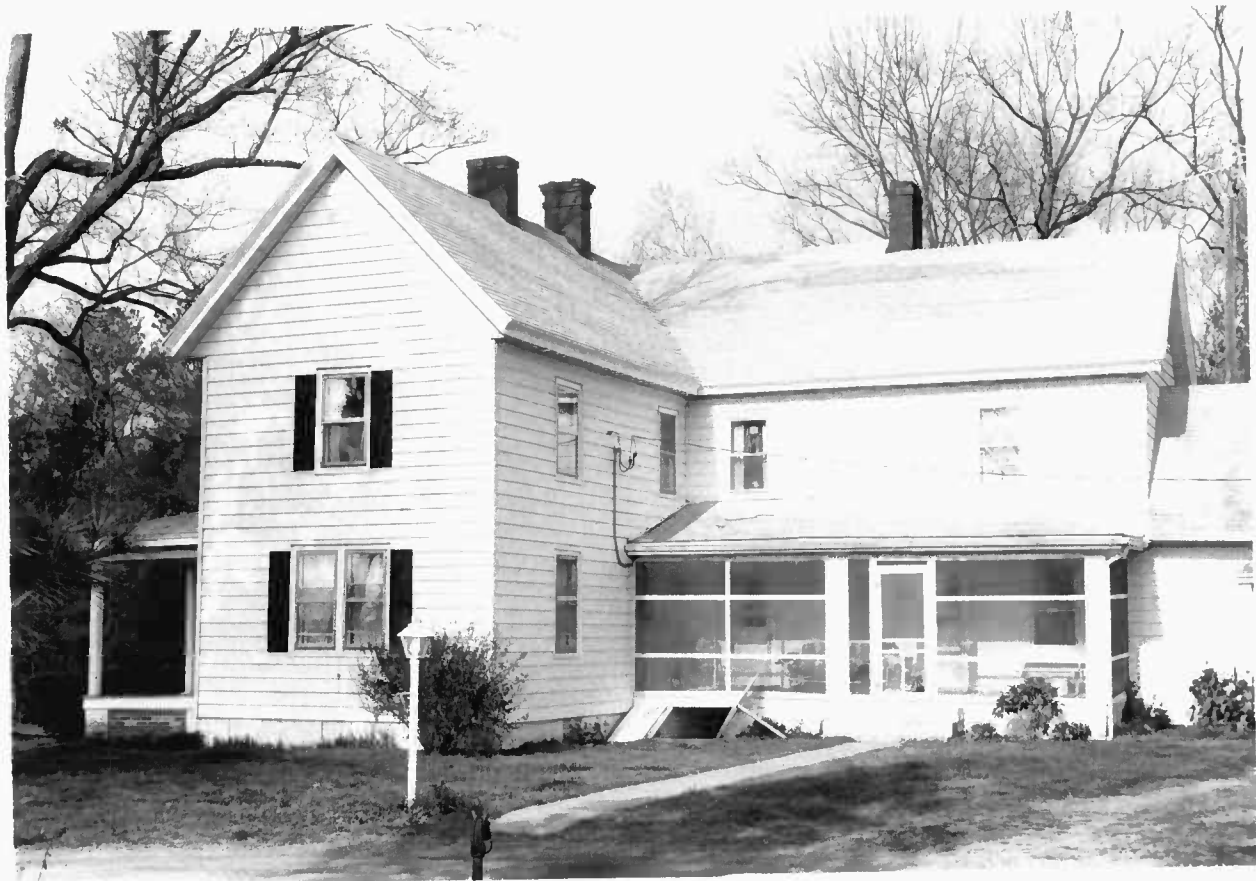
South Elevation

The south gable end has a paired single-pane sash window on the first floor and a single sash window on the second floor.

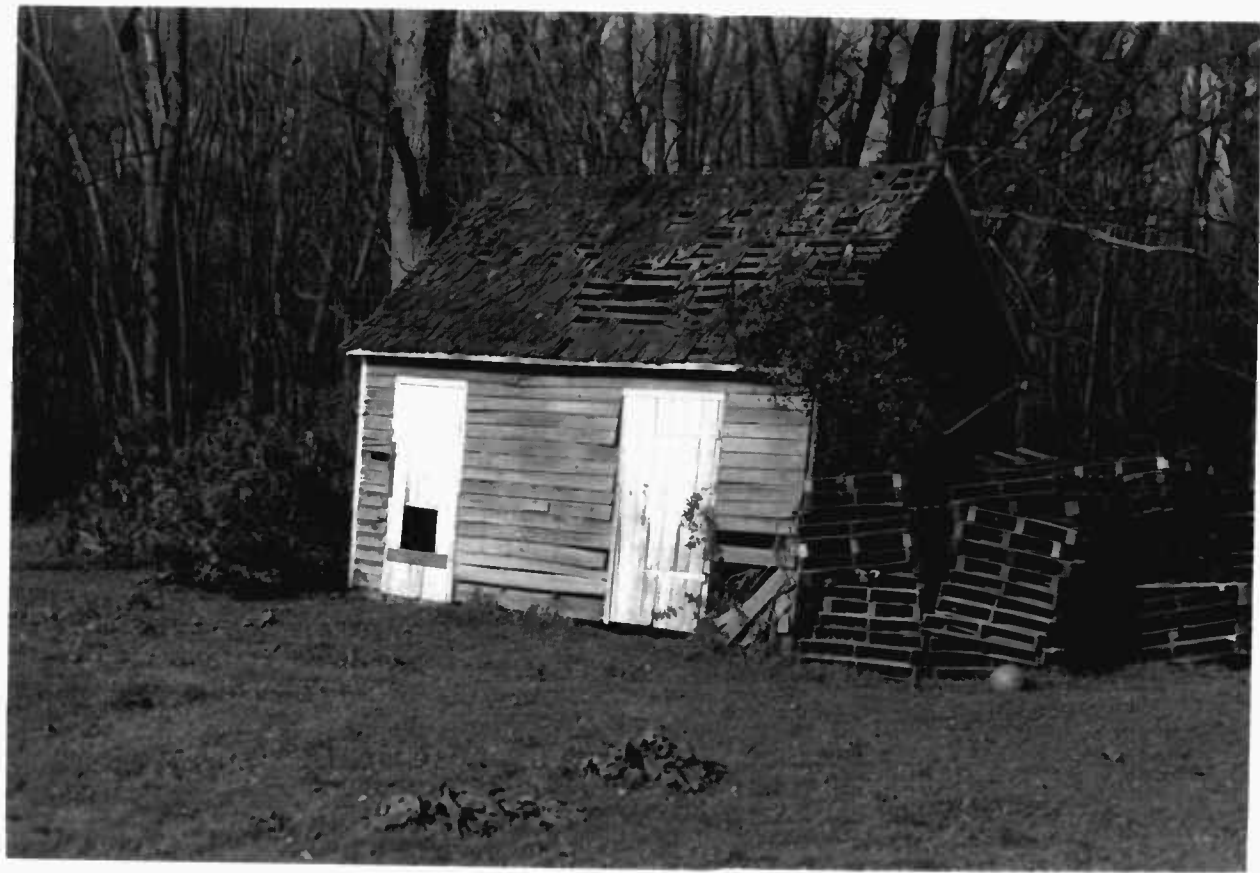
Cedar Lane Farm S-340
Princess Anne vicinity, Somerset Co., MD
Outbuilding
10/85, Paul Touart, Photographer
Neg./MD Hist. Trust

Positioned directly behind the house is a group of farm buildings including a conical silo, a granary, two corn cribs, and an outbuilding of undetermined use. The largest frame structure is the frame granary which is supported by a brick pier foundation and is sheathed by plain weatherboards. A steeply pitched gable front roof covers the center section, and a shed roof covers the flanking side rooms. Three board doors provide access to the three ground level spaces, and a smaller door opens into the loft. Flanking the granary are two corn cribs with flanking wagon bays. Both structures are supported by brick pier foundations. The north crib is covered by a continuous gable roof, whereas the south crib has a broken roofline. Located north of the crib is the round silo constructed of ribbed concrete and stabilized by metal rings. The silo is capped by conical roof. North of the house is a two-room frame outbuilding of undetermined use. Two front doors open into separate cells, and the east door has long strap hinges. The frame is covered with weatherboard siding, and the roof retains a deteriorated layer of wood shingles.

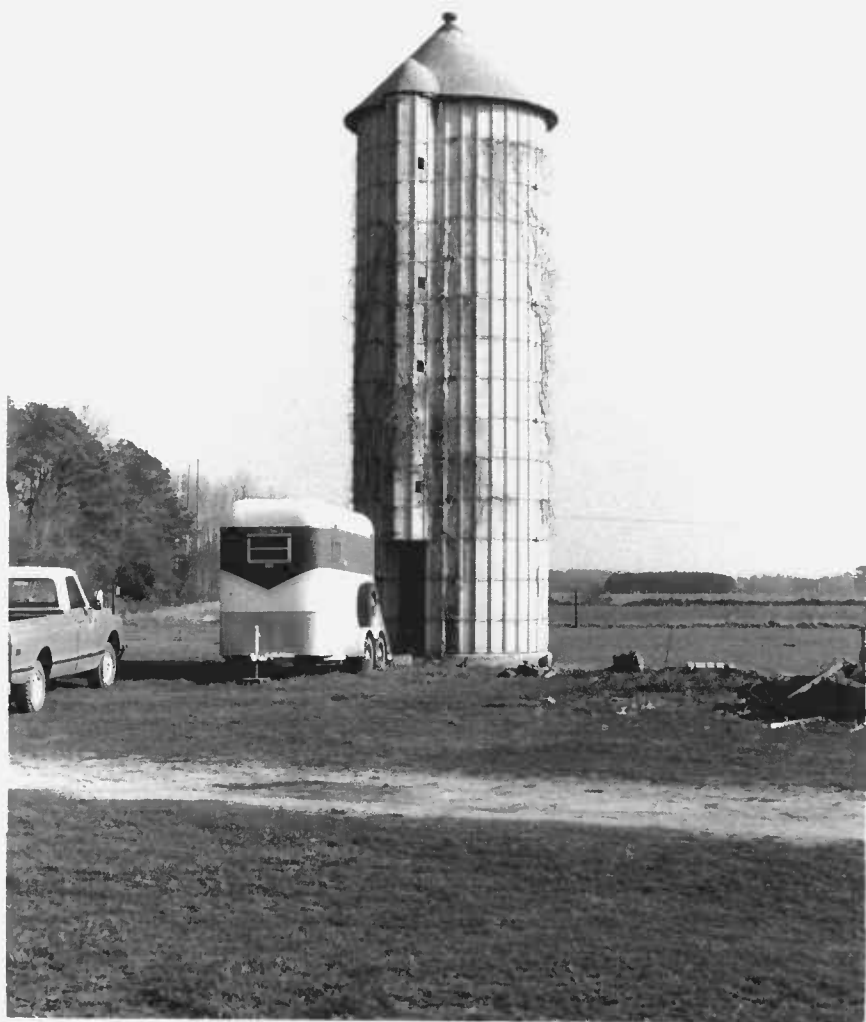
Silo

Cedar Lane farm is located on the east side of the old Princess Anne-Westover Road south of Princess Anne. The nineteenth-century cross gabled farmhouse is accompanied by a group of contemporary outbuildings. A concrete ribbed silo stands near a granary and two corn cribs. The winding entrance lane is bordered by a mature row of cedars.
